Vapor space study

Corrosion studies on **GeoBrom® HG520**

BROMINATED DERIVATIVE PRODUCTS FOR MERCURY CONTROL

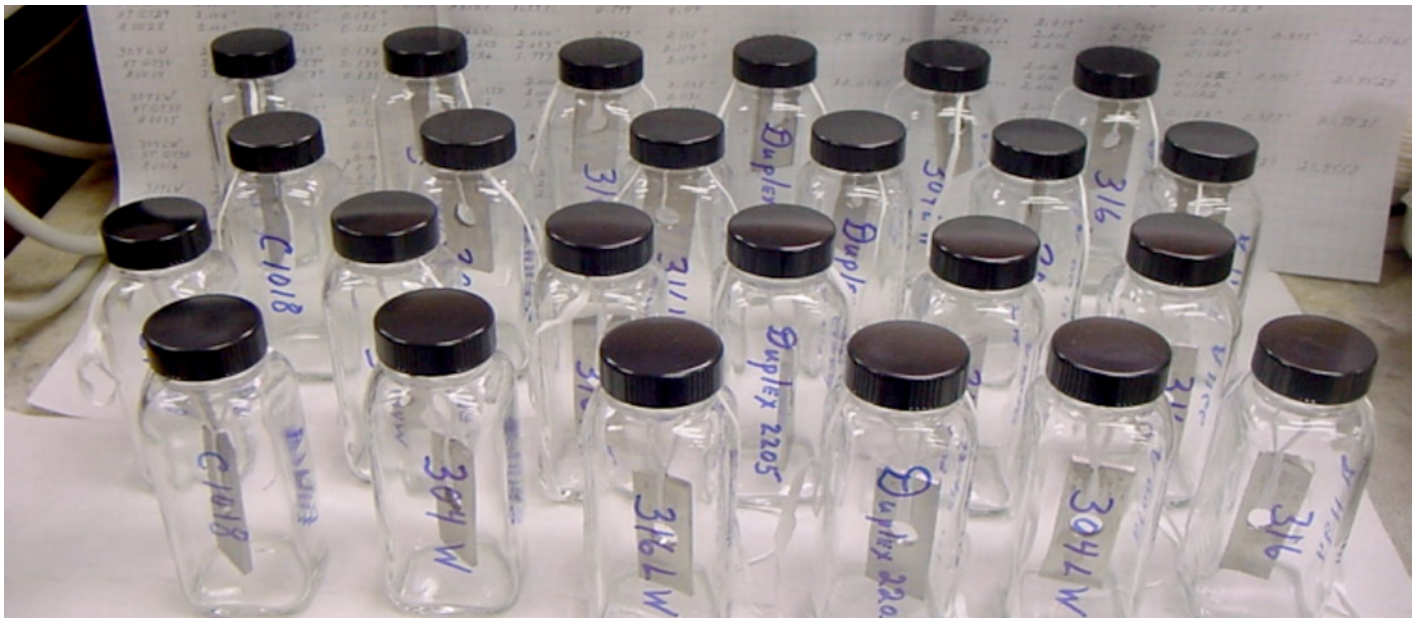
Figure 2: Test coupons before 90-day above surface exposure at 20 °C and 50 °C

Metal test coupons with dimensions of ~2.0" x 0.75" x 0.125" were supplied by an outside vendor. The vendor prepared the coupons by abrading surfaces and stamping metal type and marking specimens with a unique identification number. Prior to using, coupons were cleaned using reagent grade aqueous HCl and a bristle brush followed by a thorough deionized water rinse, degreased using acetone, dried using hot air, then allowed to cool in desiccators. The clean, dry specimens were weighed and measured. Using forceps, a four place OHAUS Galaxy Model G160D analytical balance was used to attain initial weights for all coupons. Dimensions were established using a Starrett® Micrometer part # 436RL-1, EDP 51568 and a Starrett® Dial Caliper Part # 120Z, EDP 55951. Three measurements were taken on all dimensions and averaged for the length, width, and thickness. Pictures were taken to record coupon condition prior to vapor exposure tests.

To visually document condition of test specimens, pictures were taken before and after immersion tests (see Figures 2–6).

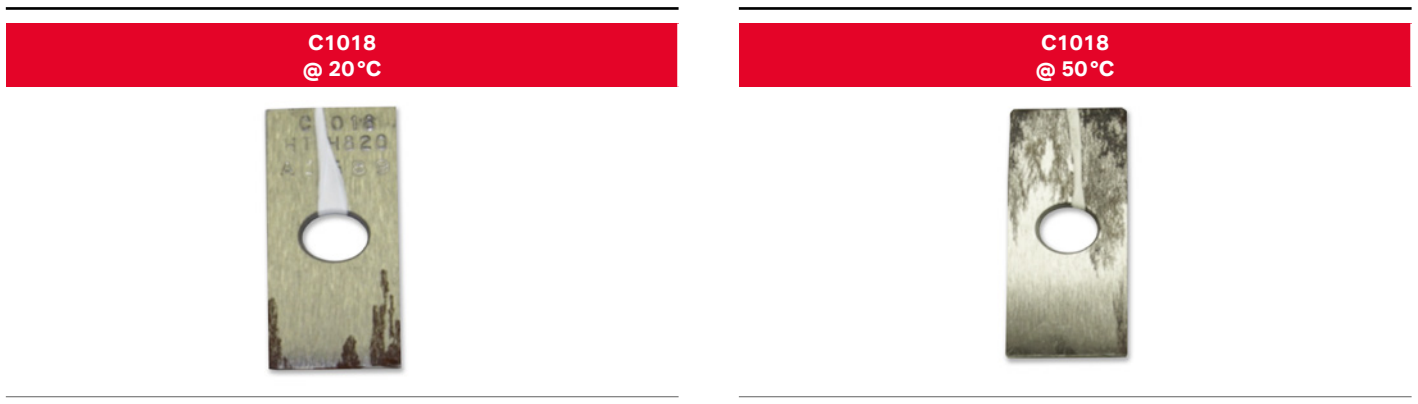
Figure 5: C1018 coupon after 90-day above surface exposure at 20 °C and 50 °C (before cleaning)

Tables 1 and 2 provide data on test specimens at 20°C and at 50°C, respectively. Corrosion rates on all specimens were under 0.10 mpy rate. Mild carbon steel C-1018 gave the highest corrosion rate at 0.025 mpy at 20°C and 0.053 mpy at 50°C. Minor surface corrosion but no pitting was observed on C-1018 coupons. There was no surface corrosion or pitting observed on any remaining specimens suspended above the liquid by ~ 3/8 inches. C-1018 corrosion is likely due to humidity in headspace of bottle.

C-1018 showed signs of a slight surface corrosion in this test and a low corrosion rate. There are a number of different corrosion standards depending on the application. Therefore, whether C-1018 is suitable for use with CaBr₂ depends on the application. These data are relevant only to the 52% CaBr₂ solution. Dilute solutions or other uses of 52% solution may exhibit different corrosive behaviors.

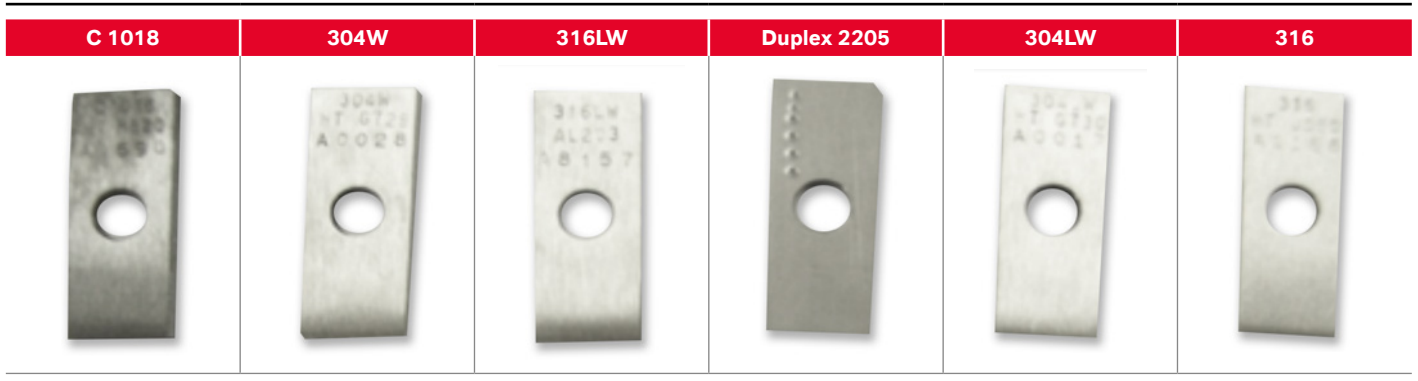
Test coupons after 90-day above surface exposure at 50 °C removed from test bottles (after cleaning)
