Total immersion study

Corrosion studies on **GeoBrom® HG520**

BROMINATED DERIVATIVE PRODUCTS FOR MERCURY CONTROL

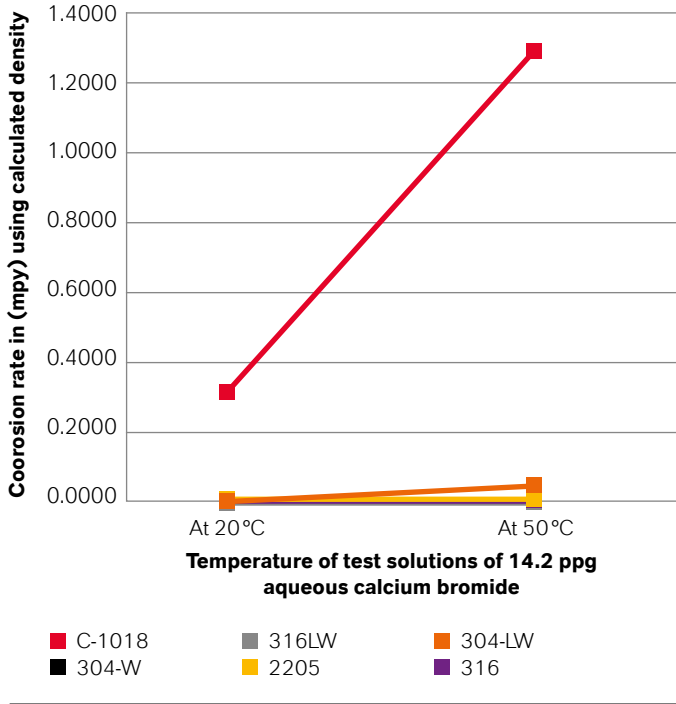
**Figure 1: Corrosion rate trend chart
(with Y axis at 0 to 1.4 mpy scale)**

**Corrosion coupons at 20°C and 50°C subsurface in
GeoBrom® HG520 calcium bromide solution**

Corrosion rates for each specimen were charted to reflect trends over the two temperatures 20°C and 50°C (see Figures 1-2).

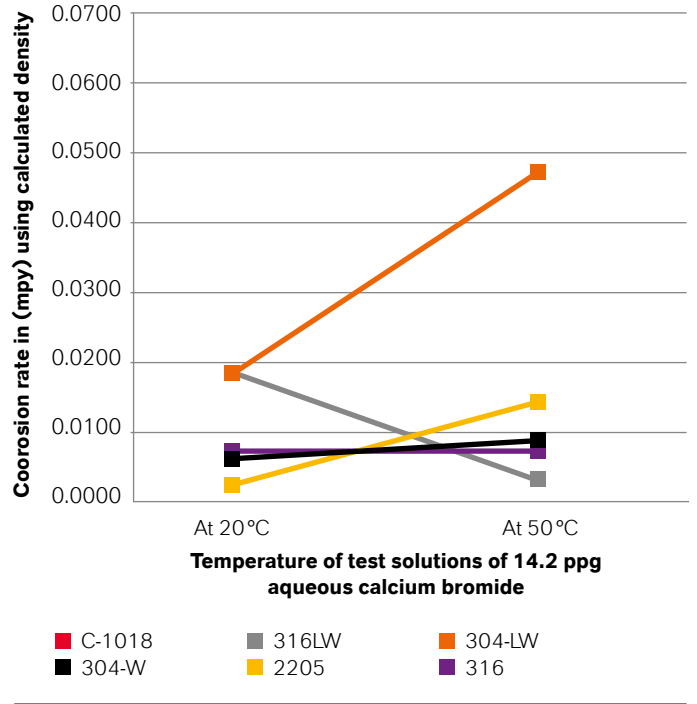
**Figure 2: Corrosion rate trend chart
(with Y axis at 0 to 0.07 mpy scale)**

**Corrosion coupons at 20°C and 50°C subsurface in
GeoBrom® HG520 calcium bromide solution**
